NEW YORK STATE
DEPARTMENT OF TRANSPORTATION

GEOTECHNICAL CONCEPTS REPORT

SR 443 Delaware Avenue Landslide

Elsmere, New York

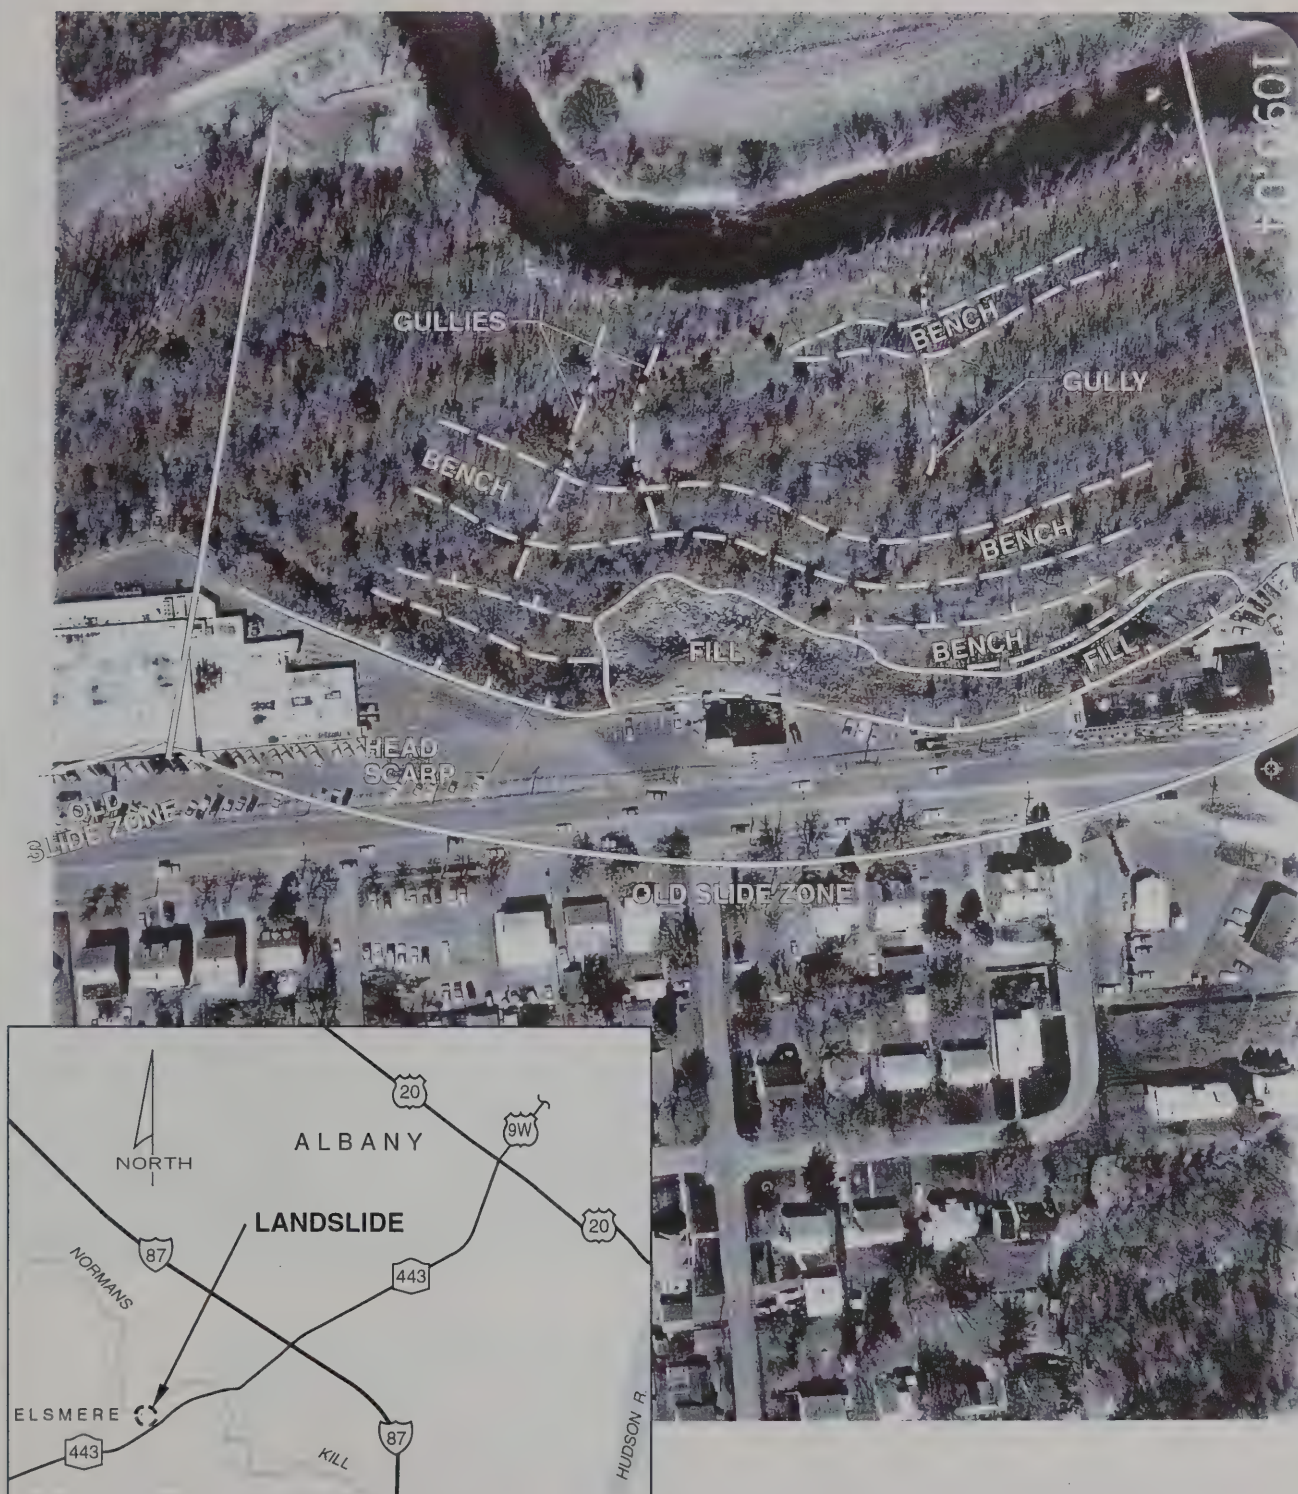
1

Aerial photographs were interpreted for evidence of landslide conditions. The 1986 photographs have been observed in stereographic projection and show landslide evidence including hummocky topography and arcuate-shaped benches, which “step” down the slope towards the river and appear to be slump blocks, as illustrated on Figure 1.

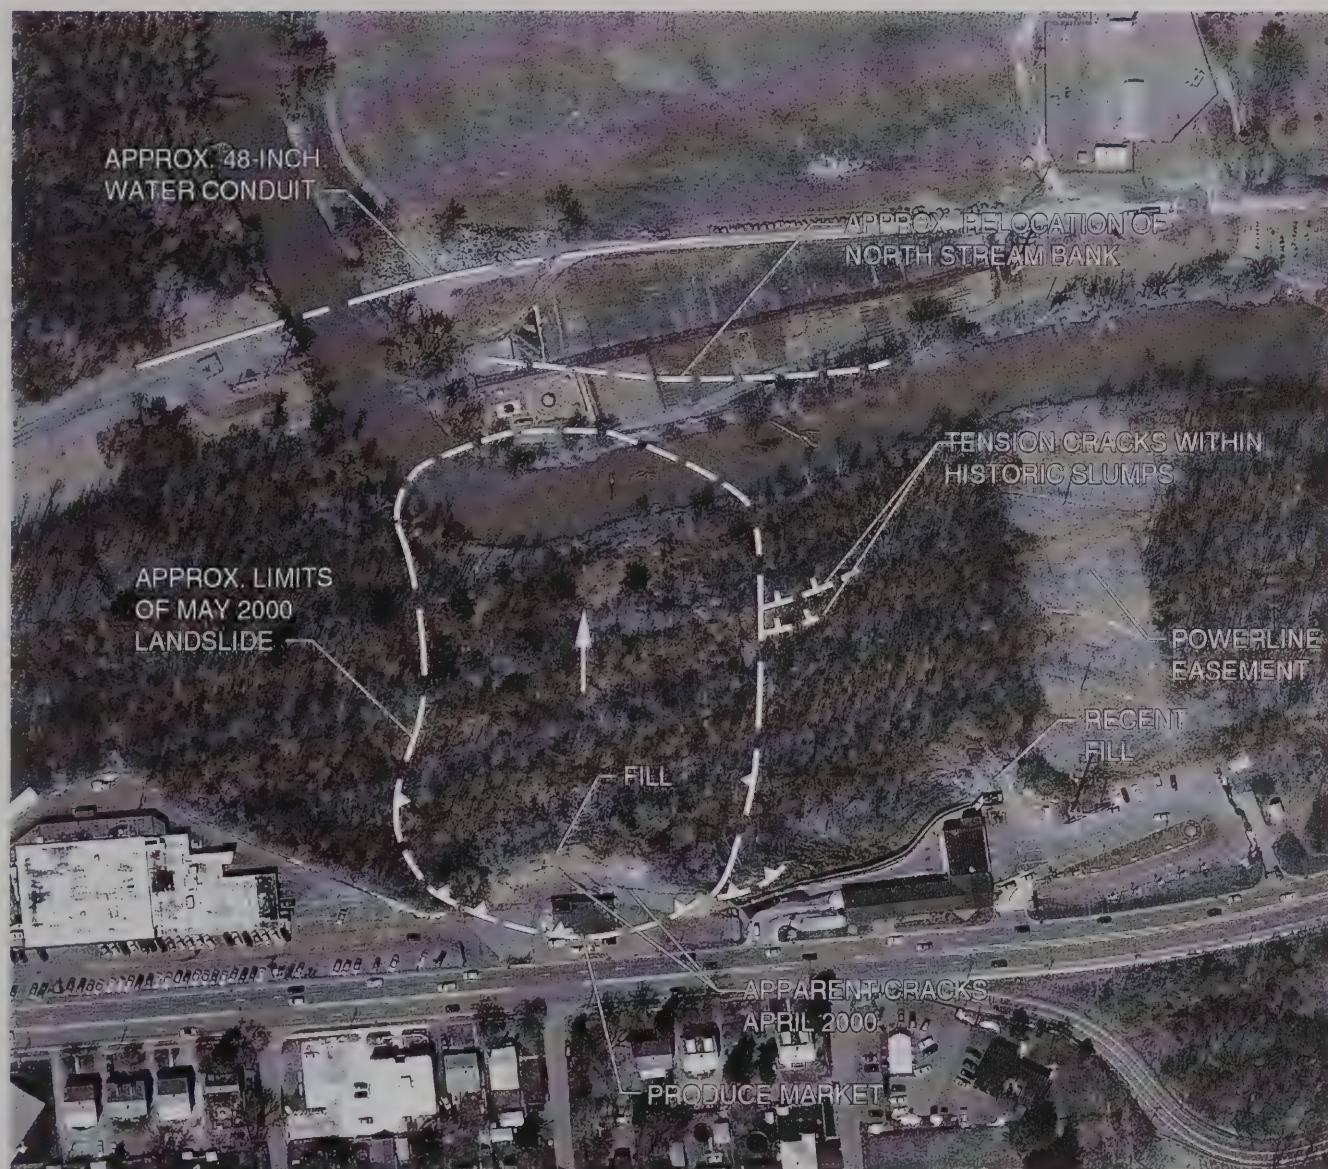
Landslide Technology 10250 S.W. Greenburg Rd. Portland, OR 97223	TITLE	LANDSLIDE SITE PLAN	DATE JUN 2000
	JOB	SR 443 DELAWARE AVE. LANDSLIDE ELSMERE, NEW YORK	JOB NO. 1280
			FIG. 2

The April 2000 aerial photograph shows apparent distress on the top of the fill behind the produce market building, as shown on Figure 2. Arcuate-shaped shadows in the surface of the fill have a shape and appearance of a series of tension cracks. Also, the south bank of the river channel appears to be slightly bowed into the river, which may be due to the landslide pushing into the river channel.

NOTE: LOCATIONS OF LANDSLIDE FEATURES ARE APPROXIMATE AND BASED ON MAY 2000 RECONNAISSANCE

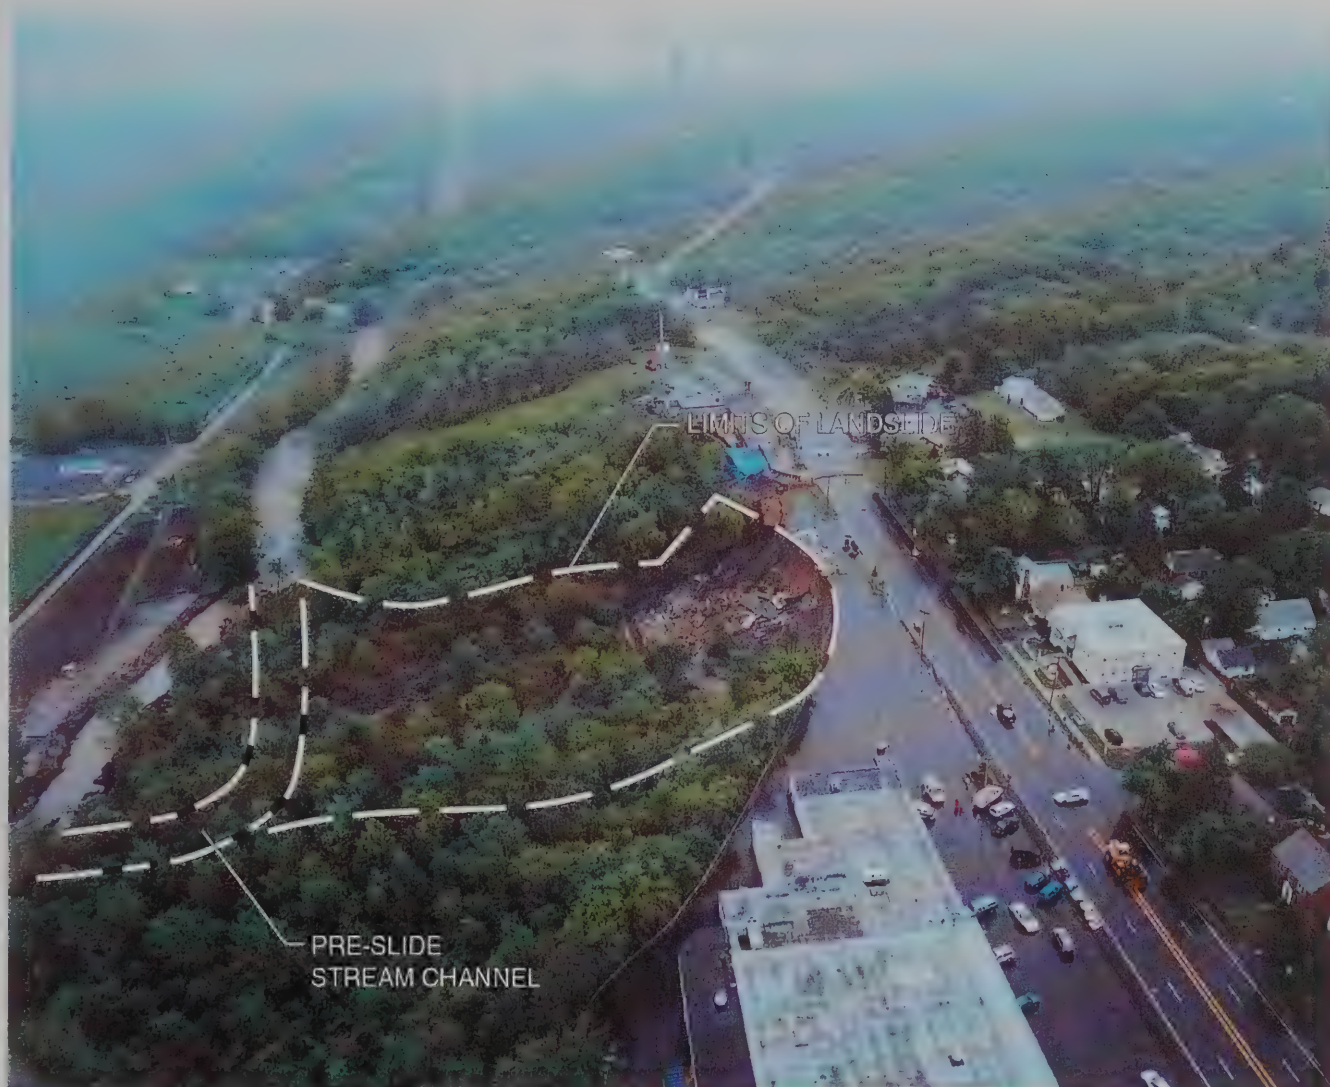
<p>Landslide Technology 10250 S.W. Greenburg Rd. Portland, OR 97223</p>	TITLE OBLIQUE PHOTOGRAPH		DATE JUN 2000
	JOB SR 443 DELAWARE AVE. LANDSLIDE ELSMERE, NEW YORK		JOB NO. 1280
			FIG. 3

NOTE: NYSDOT PHOTO, MAY 19, 2000 LOOKING TOWARD
THE NORTHEAST

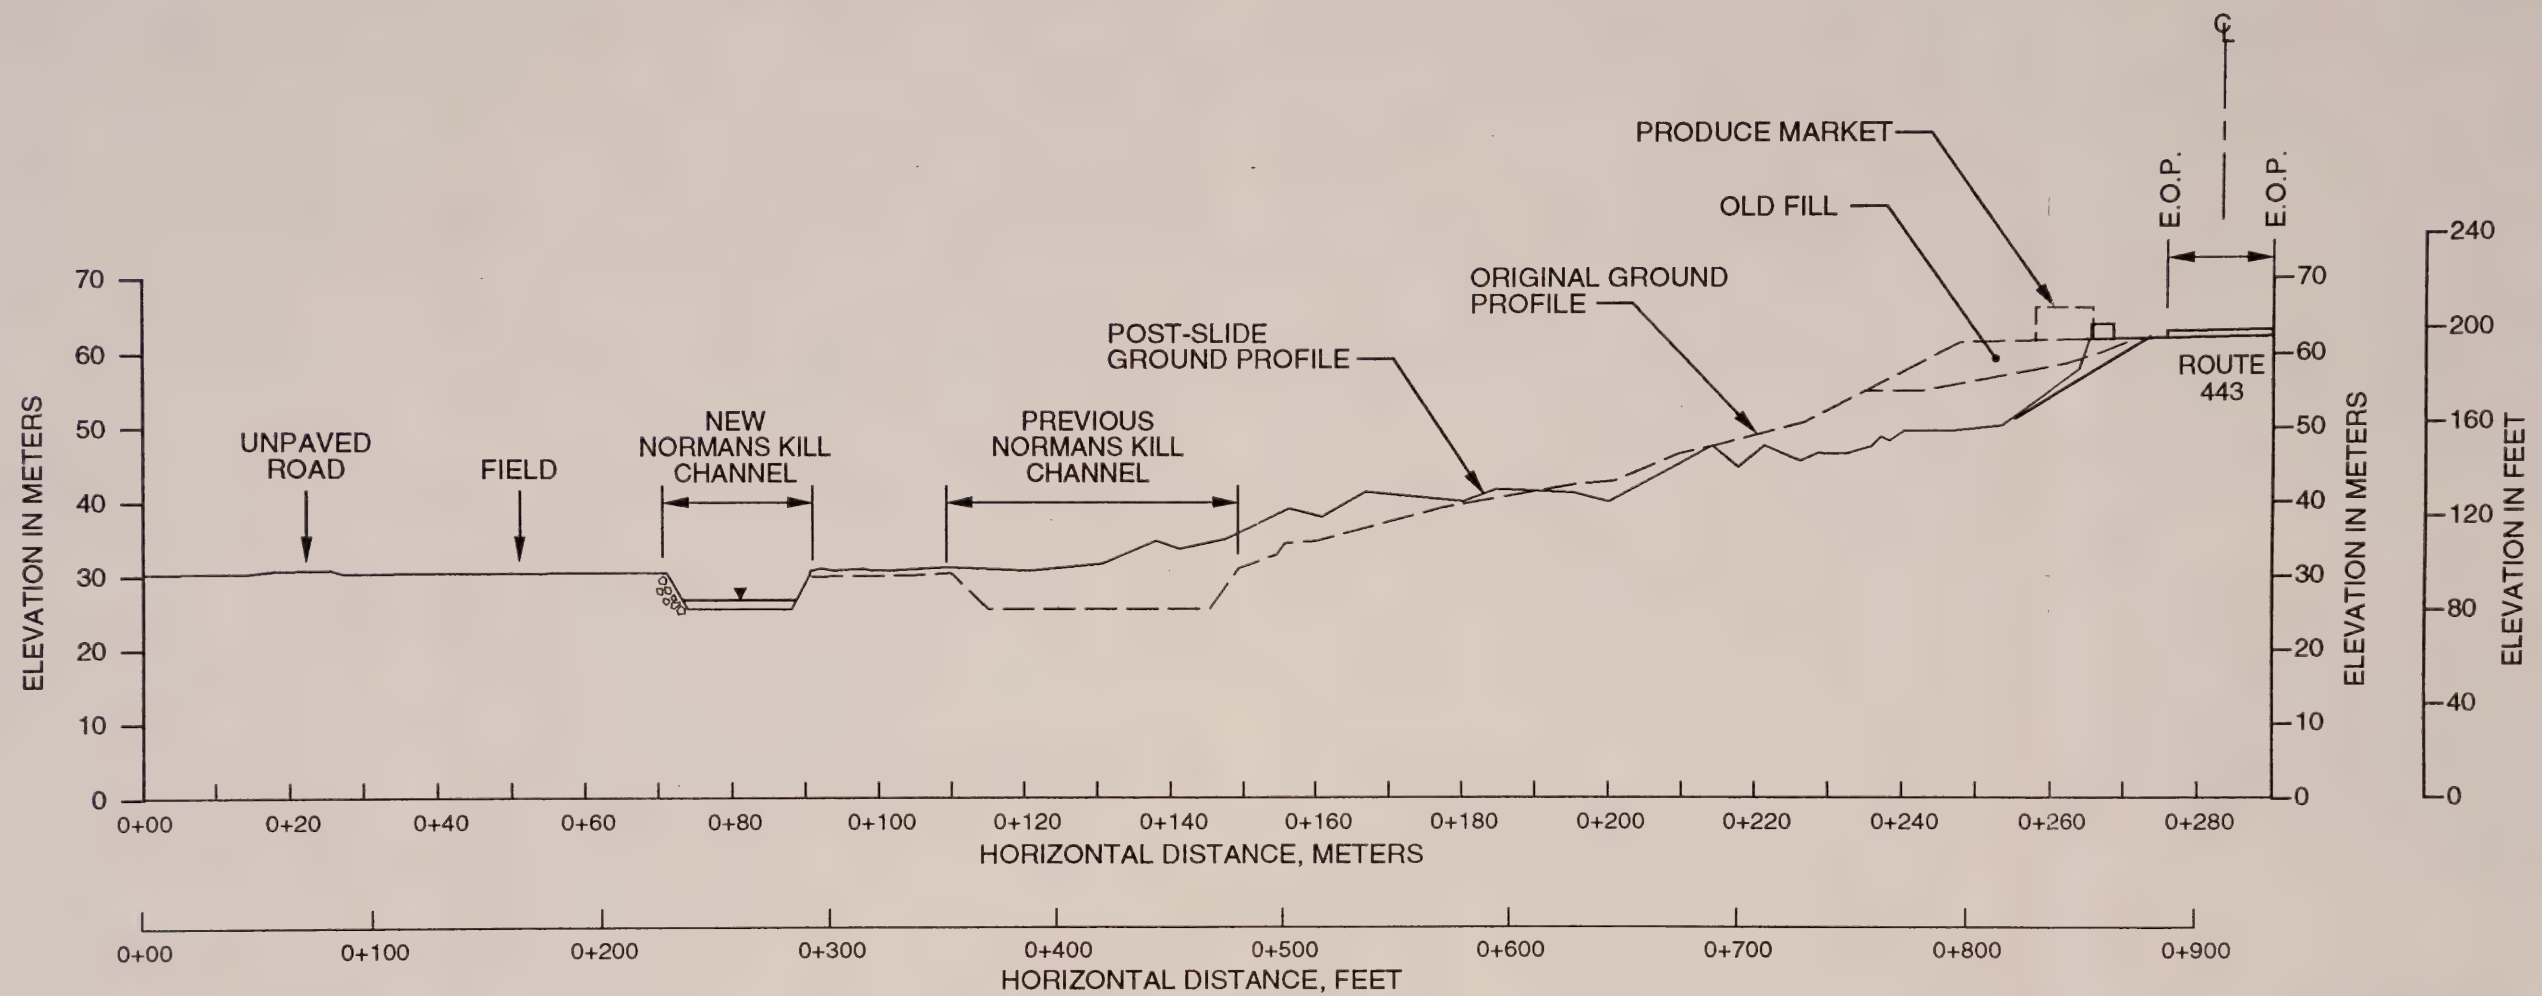
Landslide Technology 10250 S.W. Greenburg Rd. Portland, OR 97223	TITLE		1280\FIGURE04 LJW	
	CROSS SECTION		DATE	JUN 2000
	JOB		JOB NO.	1280
	SR 443 DELAWARE AVE. LANDSLIDE ELSMERE, NEW YORK		FIG.	4

POST-SLIDE CROSS SECTION BASED ON
NYSDOT SURVEY, MAY 24, 2000

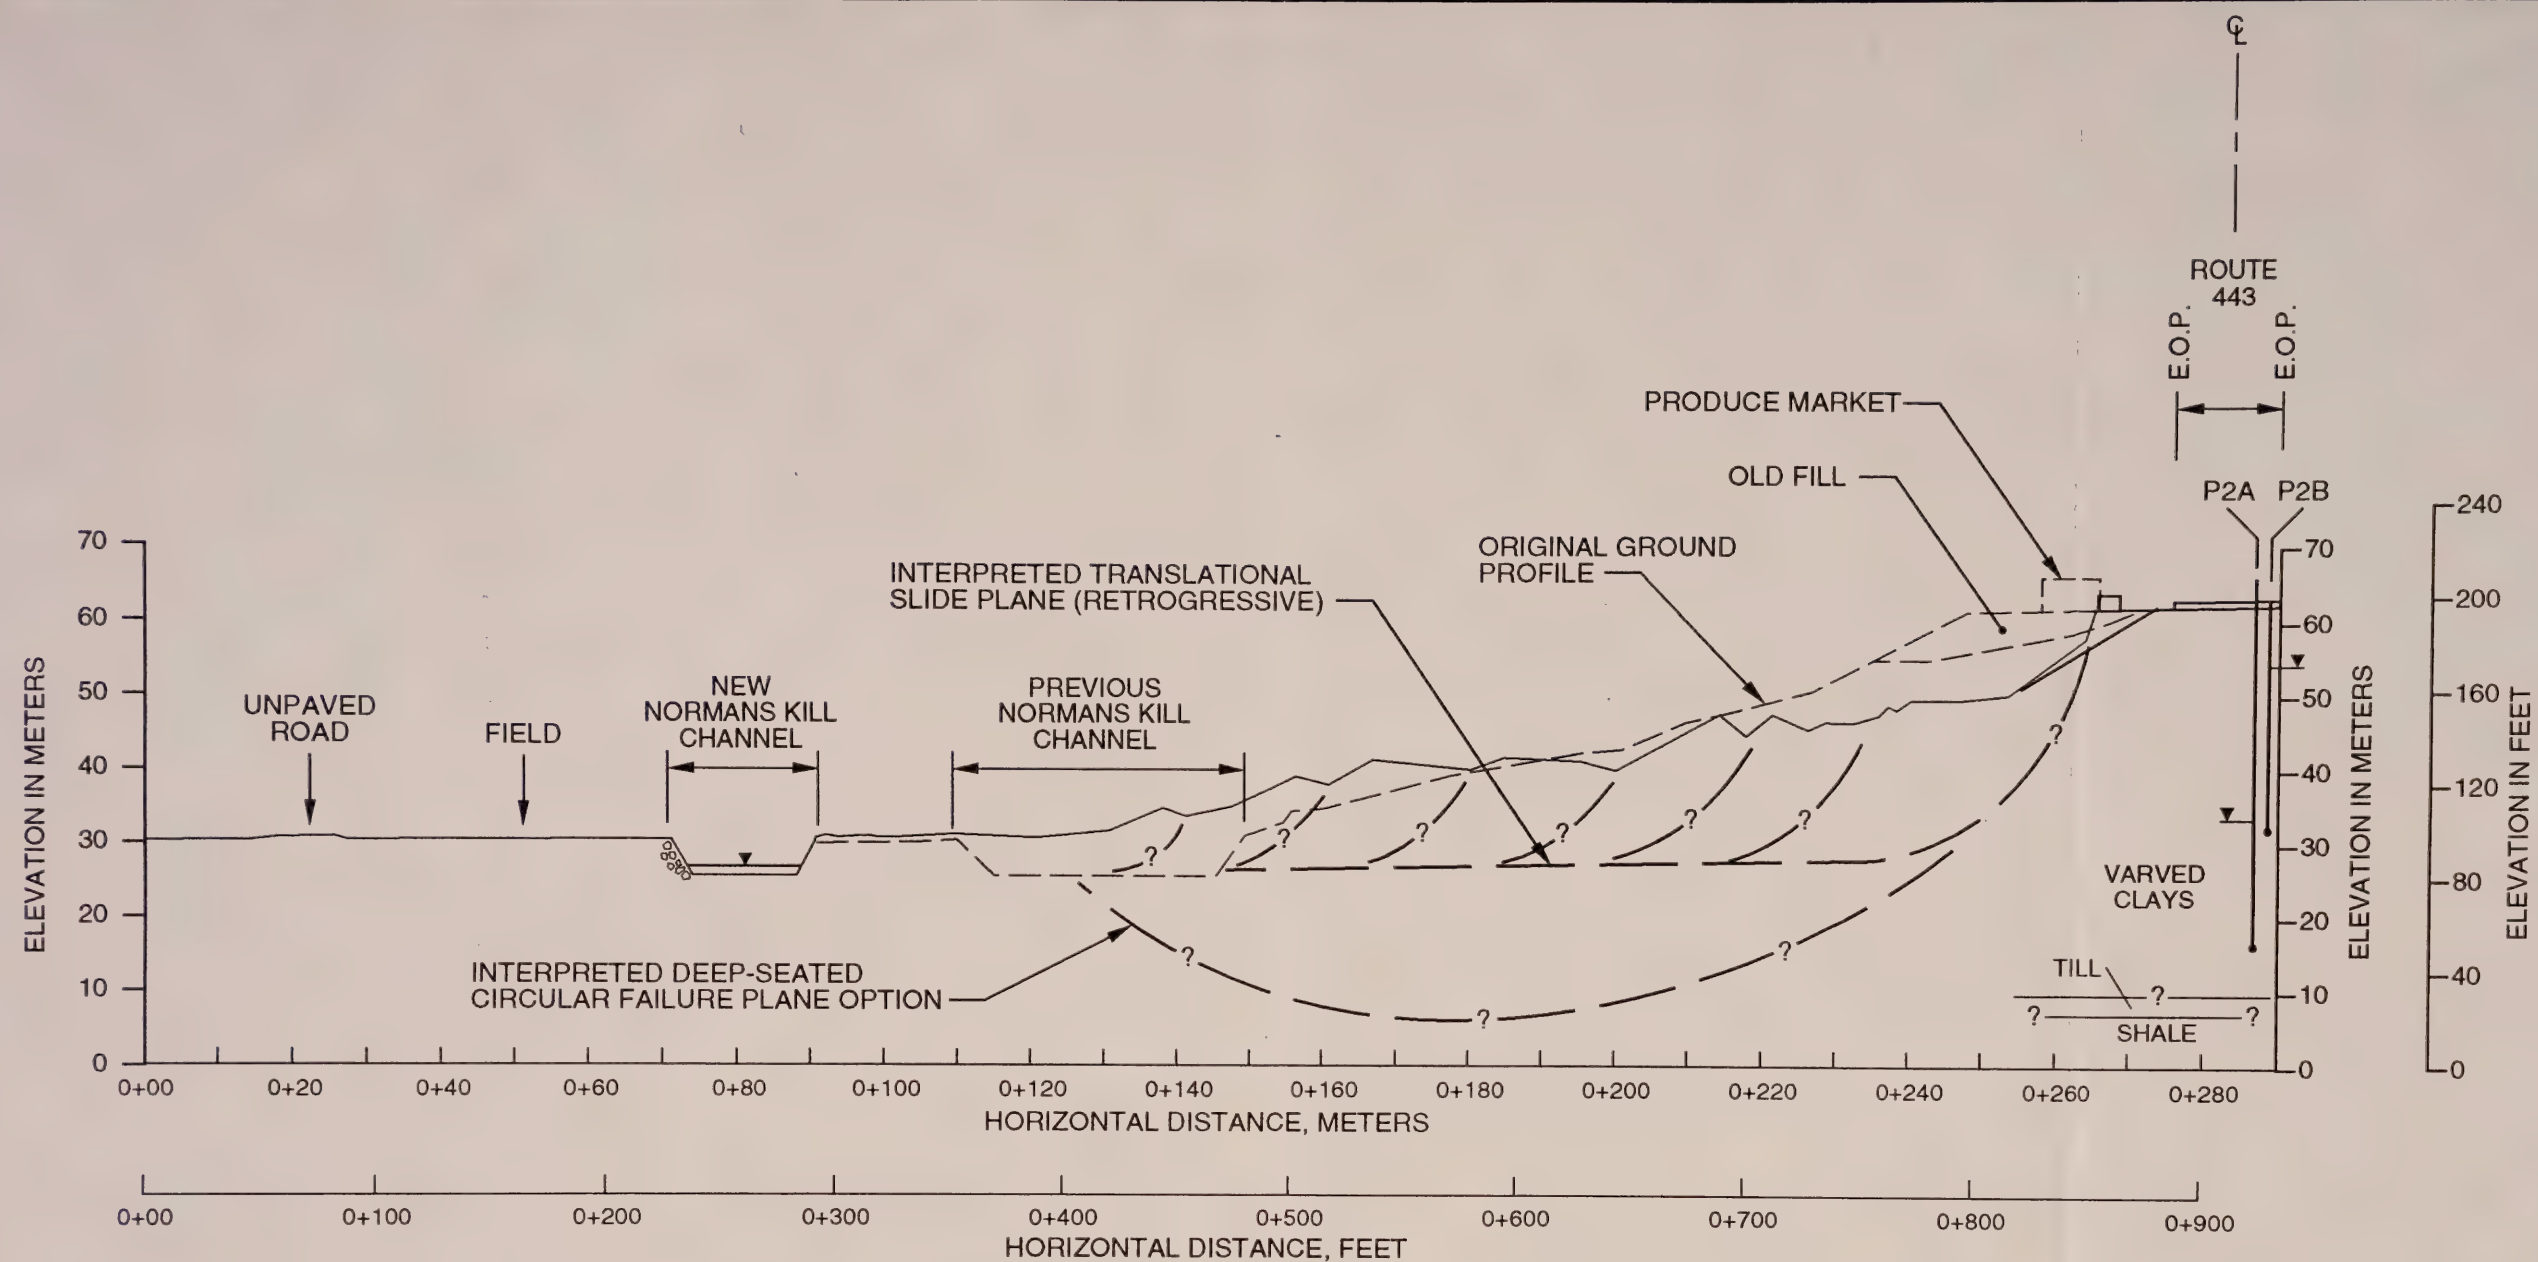
FIG.
5

The landslide mechanism could be either a near-horizontally moving block on weak varved clay or a deep-seated circular slide, as shown on the Subsurface Conditions Cross Section, Figure 5. The depth of the landslide from the highway elevation is deeper than the highest headscarp observed (70 feet), and is likely in the order of 90 to 120 feet deep. Since the landslide occurred rapidly and that the main slide mass is apparently no longer moving, it is our opinion that the slide has overcompensated (built a new larger toe) and has achieved a higher level of stability. Analyses would need to be performed to estimate the degree of stability achieved.

NOTE: GROUNDWATER LEVELS IN P2A AND P2B
MEASURED ON 6-2-00

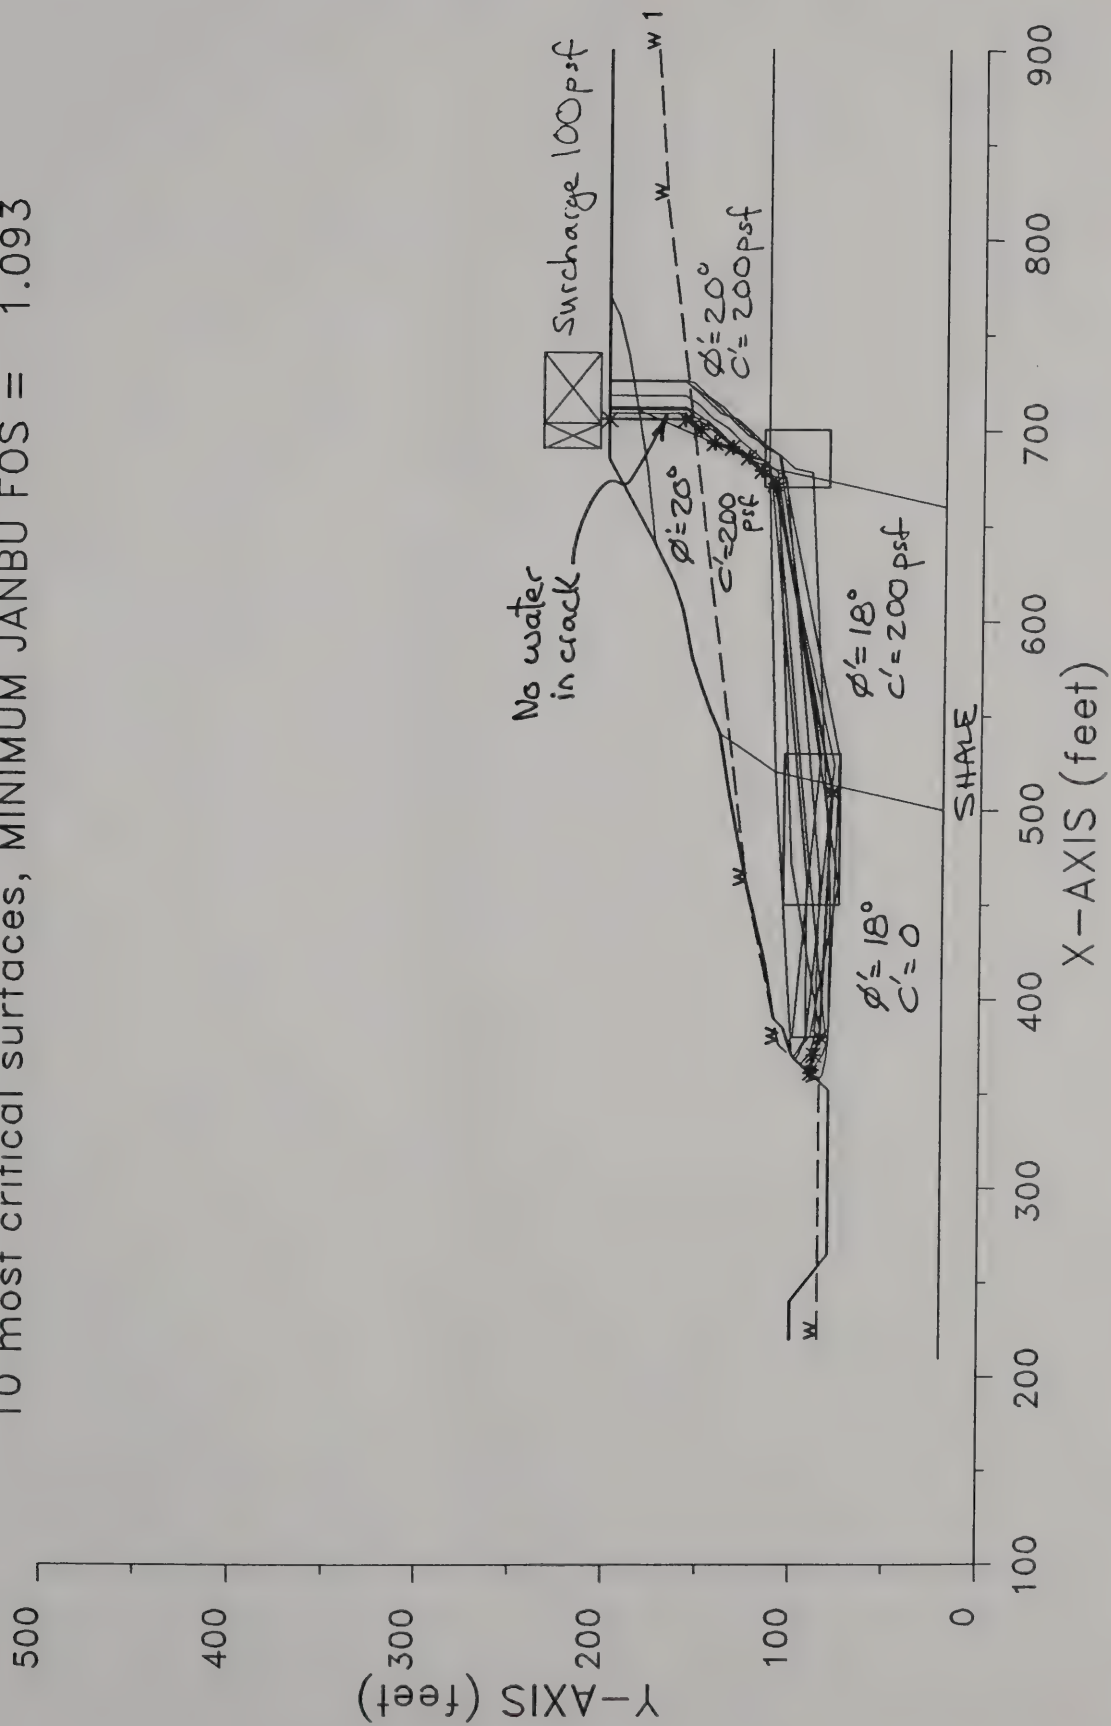
Normans Kill Slide, Initiate, surch
 10 most critical surfaces, MINIMUM JANBU FOS = 1.093

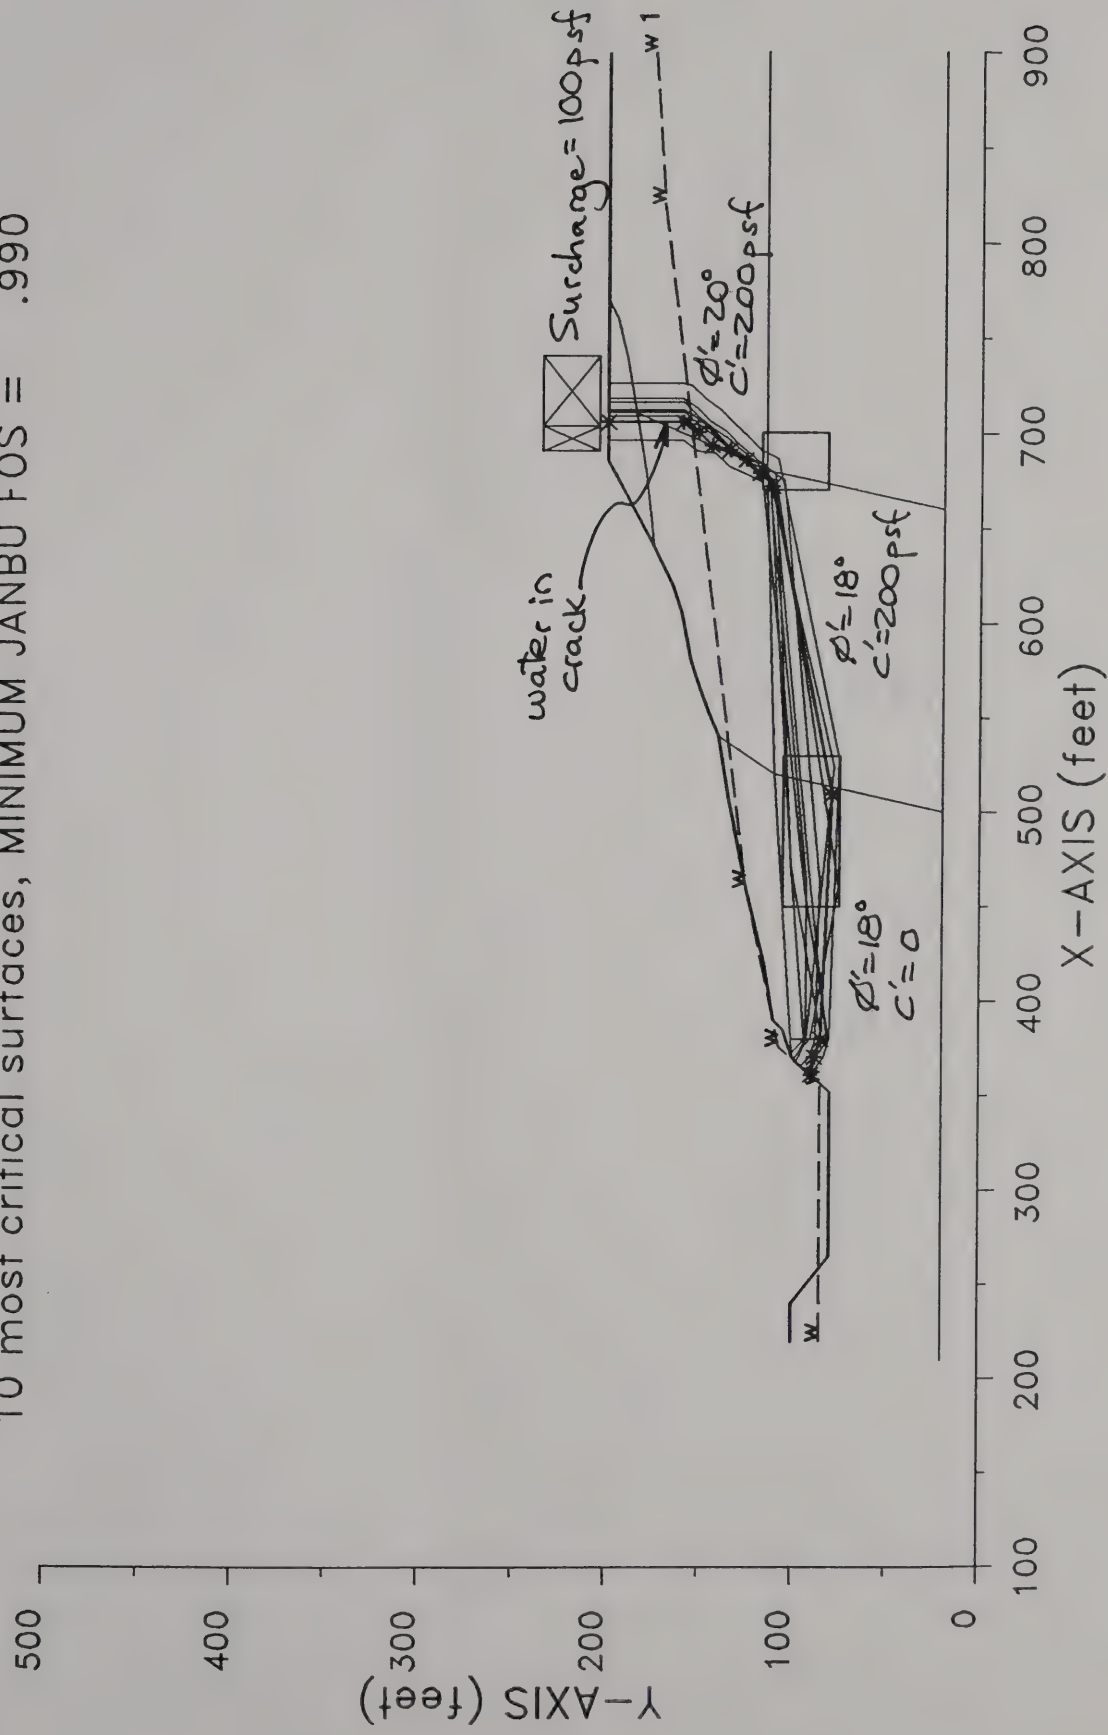
Normans Kill Slide, Initiate, surch
 10 most critical surfaces, MINIMUM JANBU FOS = .990

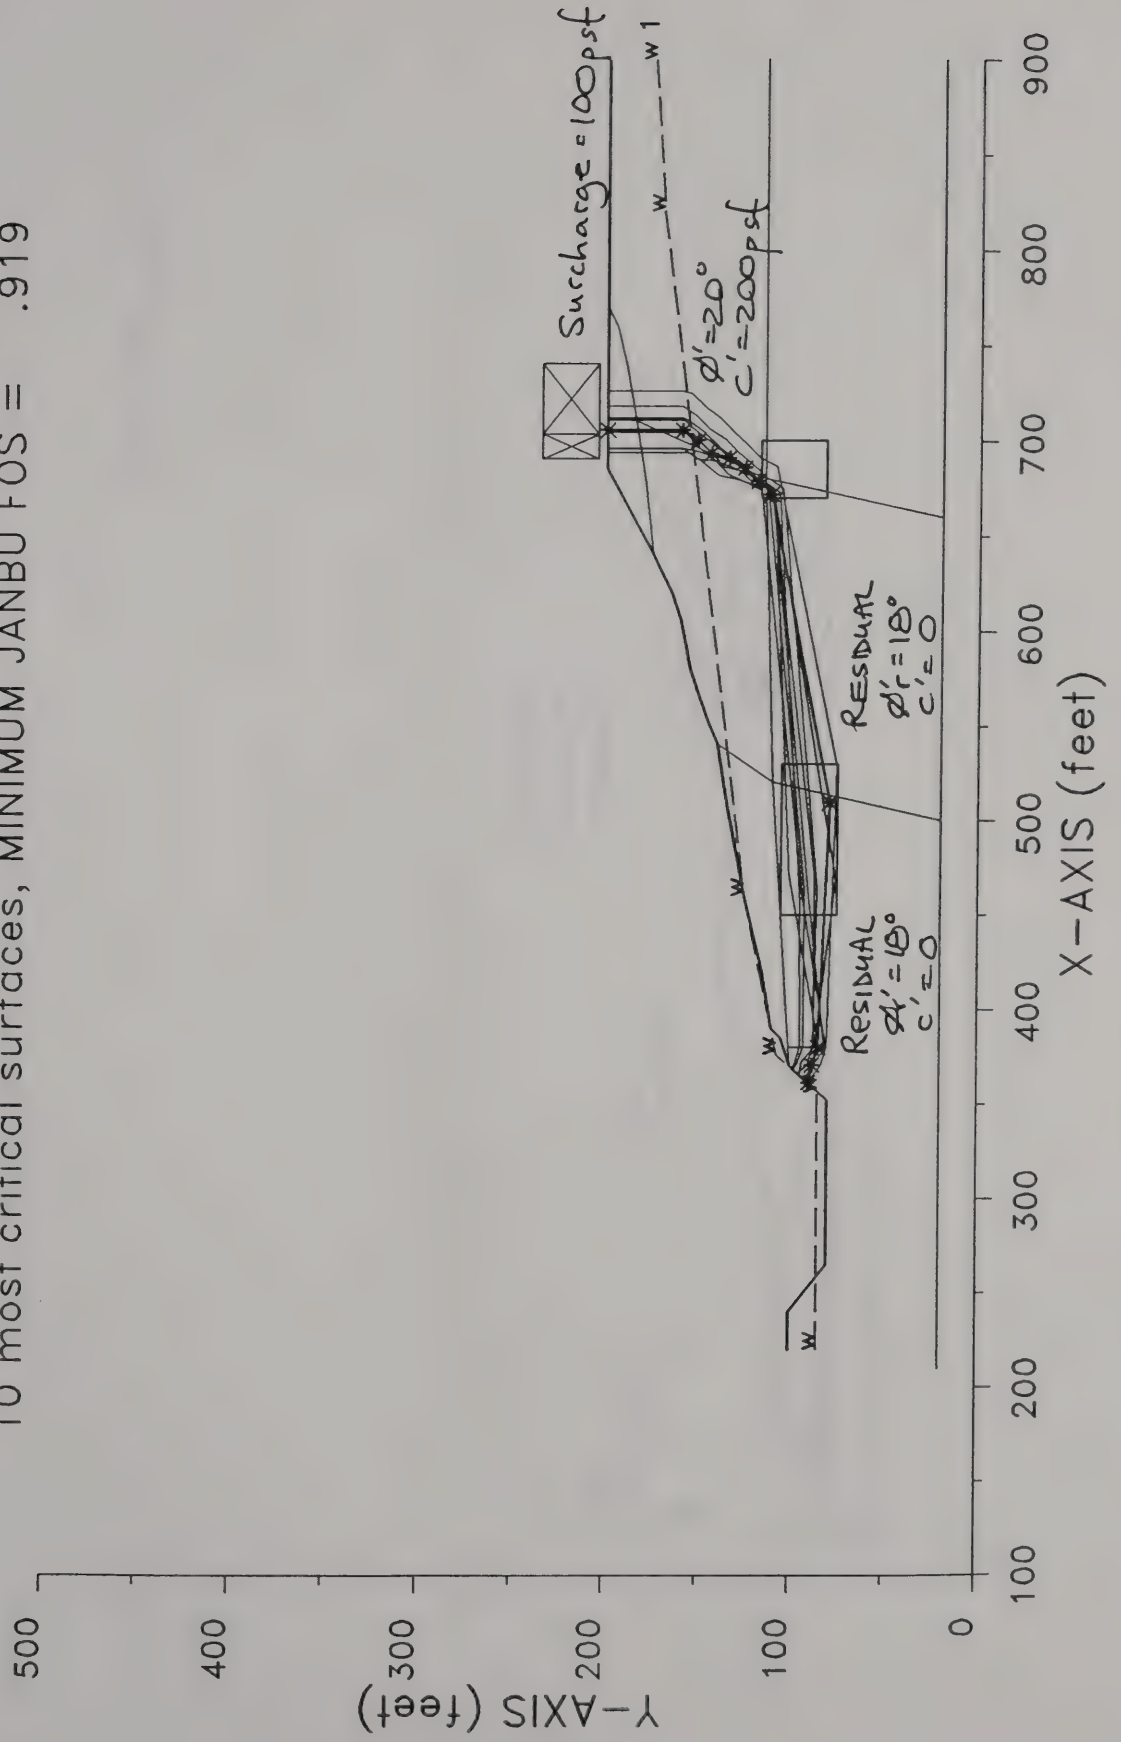
Normans Kill Slide, Initiate, Residual
 10 most critical surfaces, MINIMUM JANBU FOS = .919

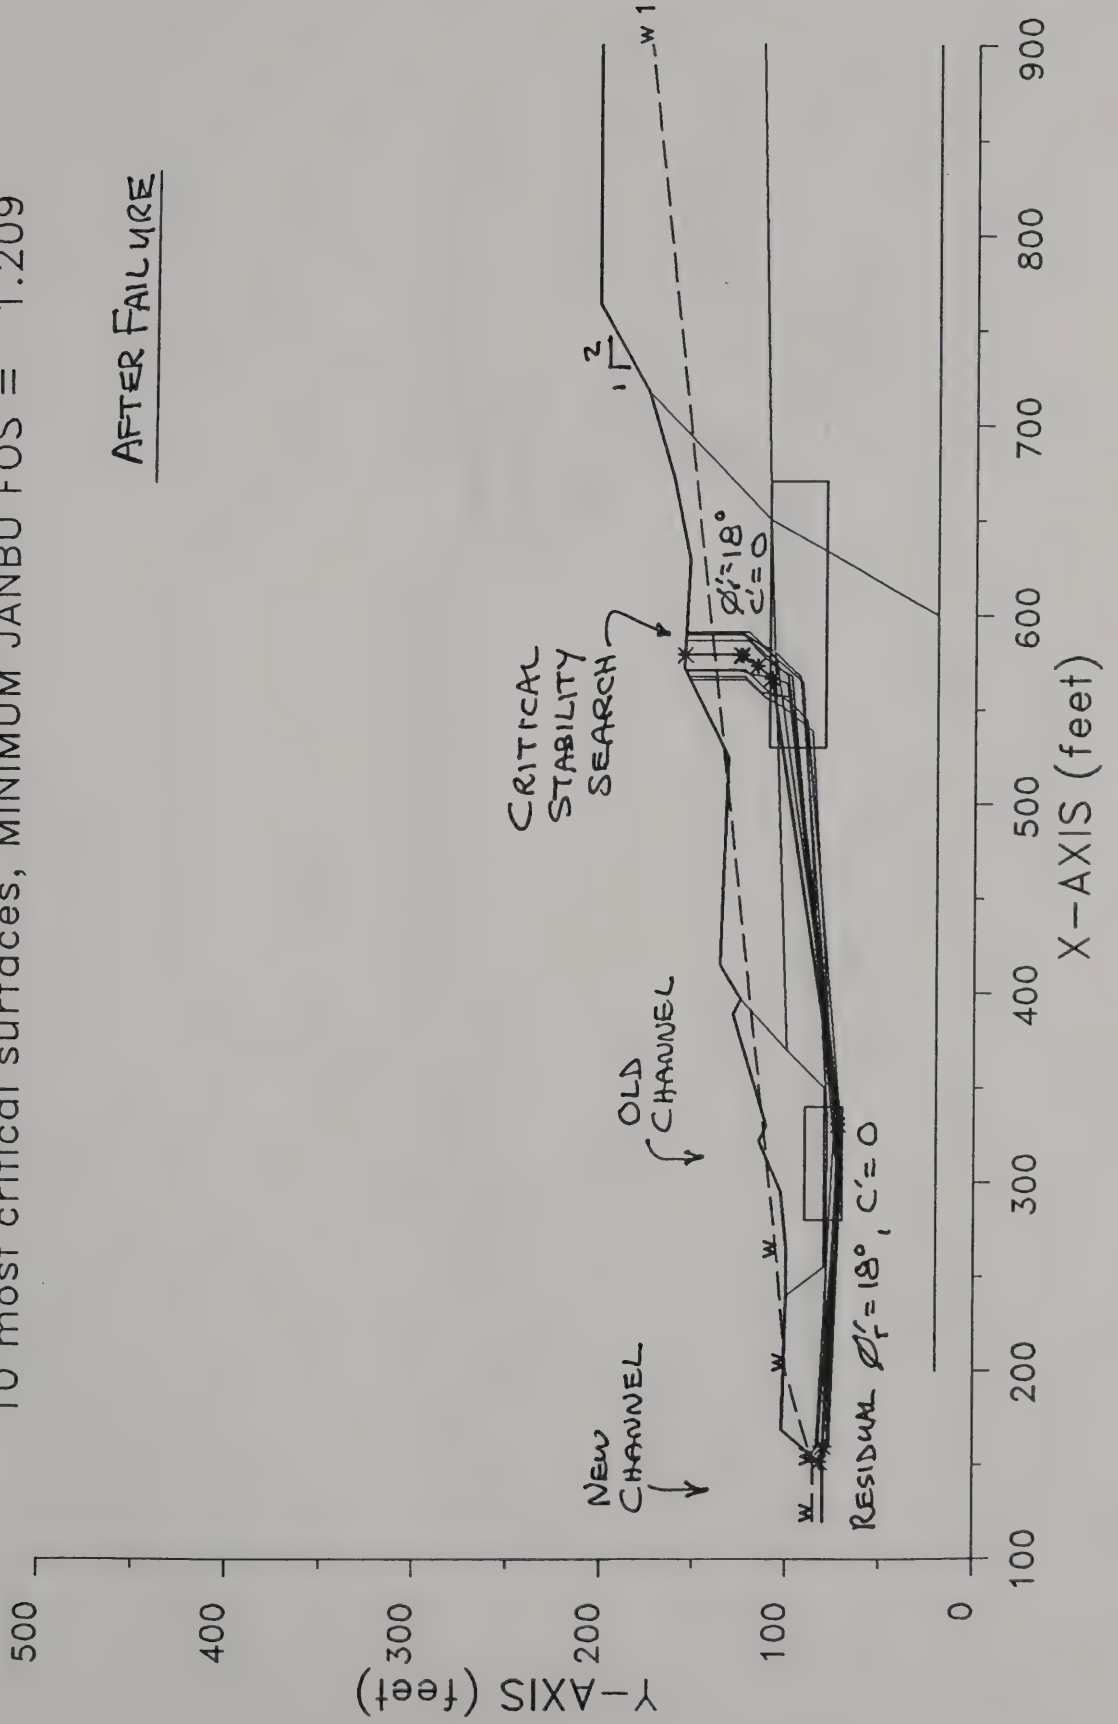
Normans Kill, effectstress, gwt 175'
 10 most critical surfaces, MINIMUM JANBU FOS = 1.209

AFTER FAILURE

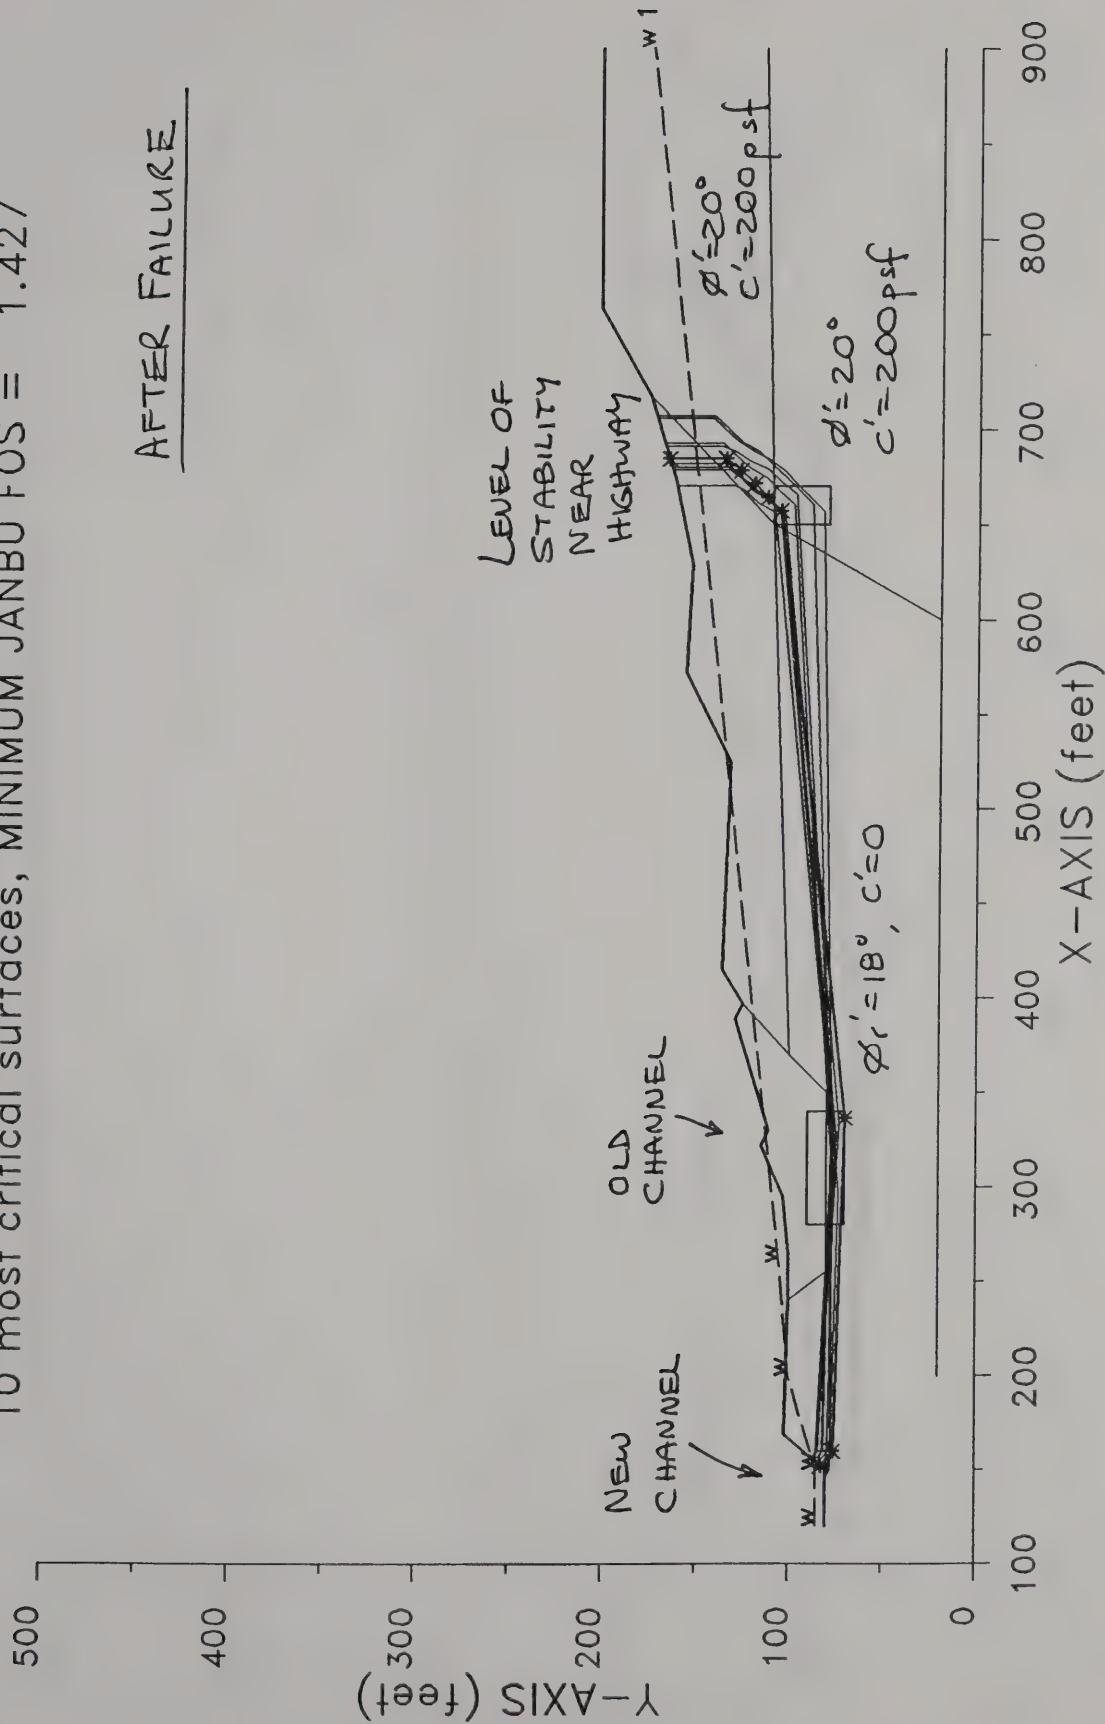
Normans Kill, effectstress, gwt 175'
 10 most critical surfaces, MINIMUM JANBU FOS = 1.427

AFTER FAILURE

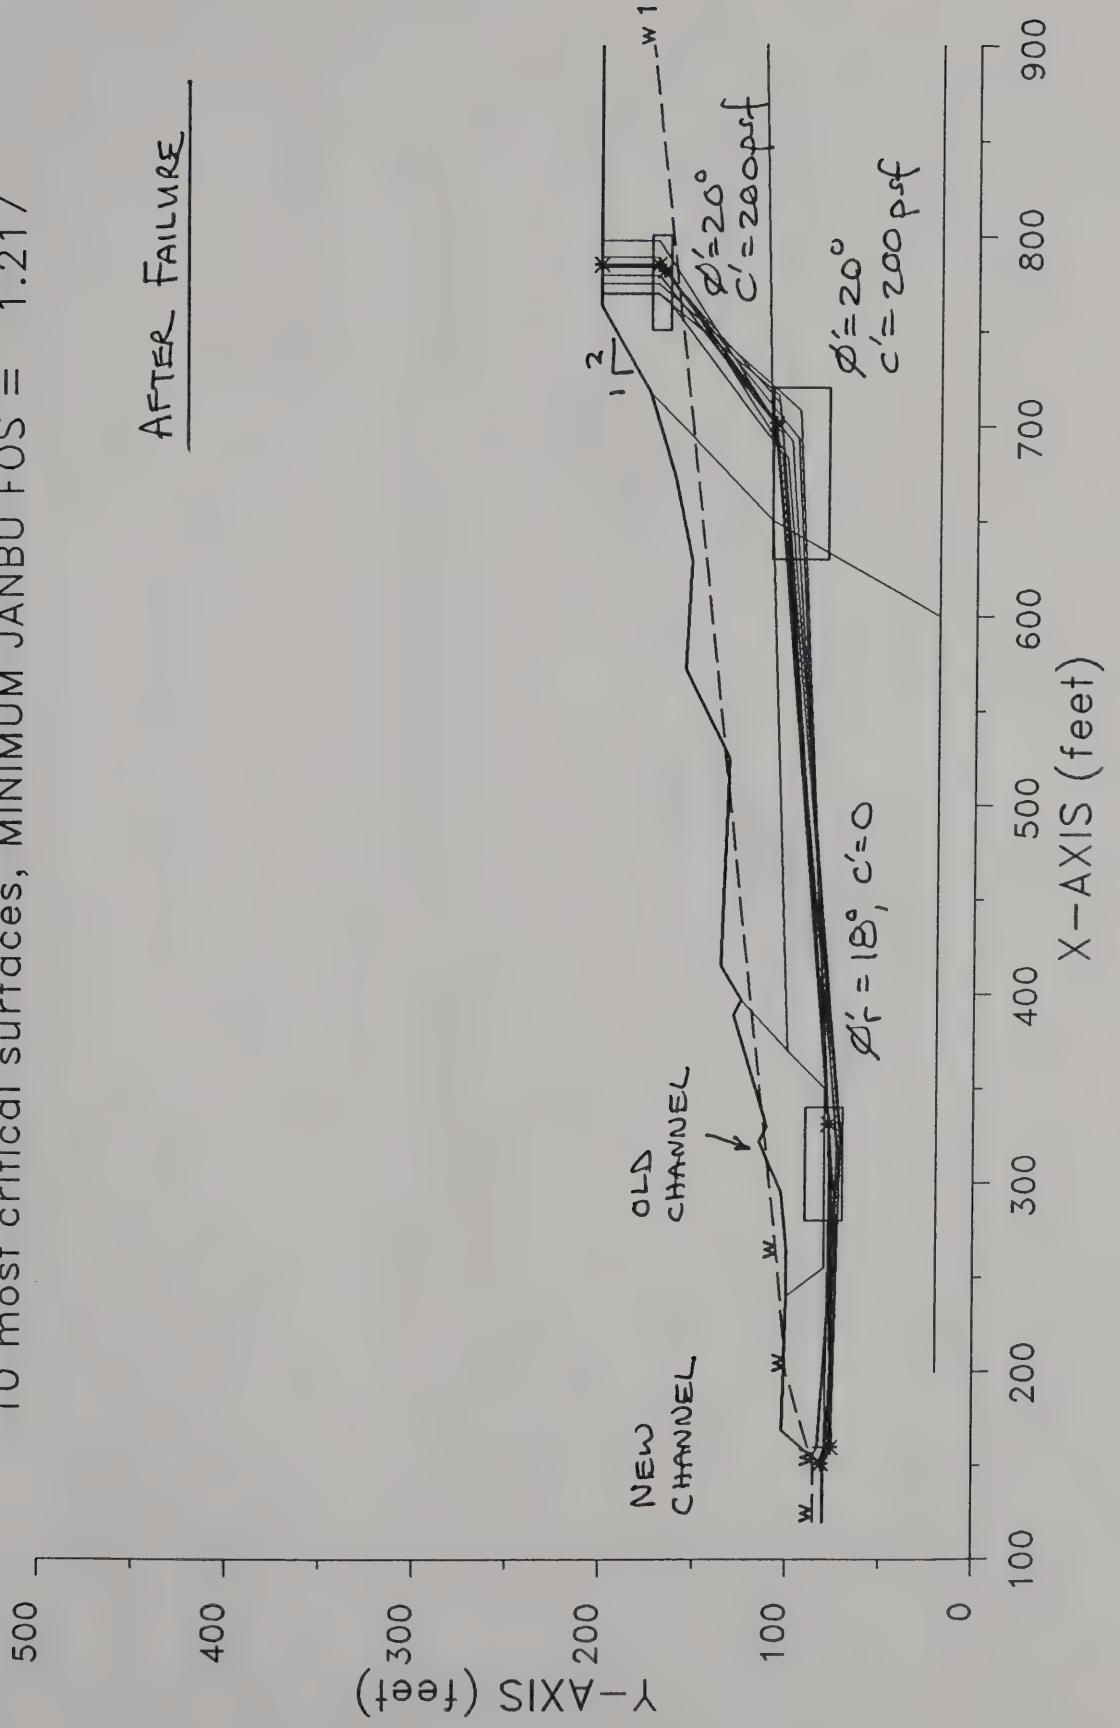
Normans Kill, effectstress, gwt 175'
 10 most critical surfaces, MINIMUM JANBU FOS = 1.217

AFTER FAILURE
